MICHIGAN DEPARTMENT OF TRANSPORTATION

STR 4532

BRIDGE SAFETY INSPECTION REPORT

Facility MILL STREET	Latitude / Longitude 42.11 / -84.2457	MDOT Structure ID 384093200038B01	Structure Condition Fair Condition(5)
Feature SO BRANCH RAISIN RIVER	Length / Width / Spans 34.8 / 25.6 / 3	Owner City: BROOKLYN(0932)	
Location 0.10 MI E OF M-50	Built / Recon. / Paint / Ovly. 1925 / 1984 / /	TSC Jackson(15)	Operational Status P Posted for load(17NNNN)
Region / County University(6) / Jackson(38)	Material / Design 8 Masonry / 11 Arch- Deck, Filled Sp	Last NBI Inspection 11/21/2017 / VMC8	Scour Evaluation 5 Stable w/in footing

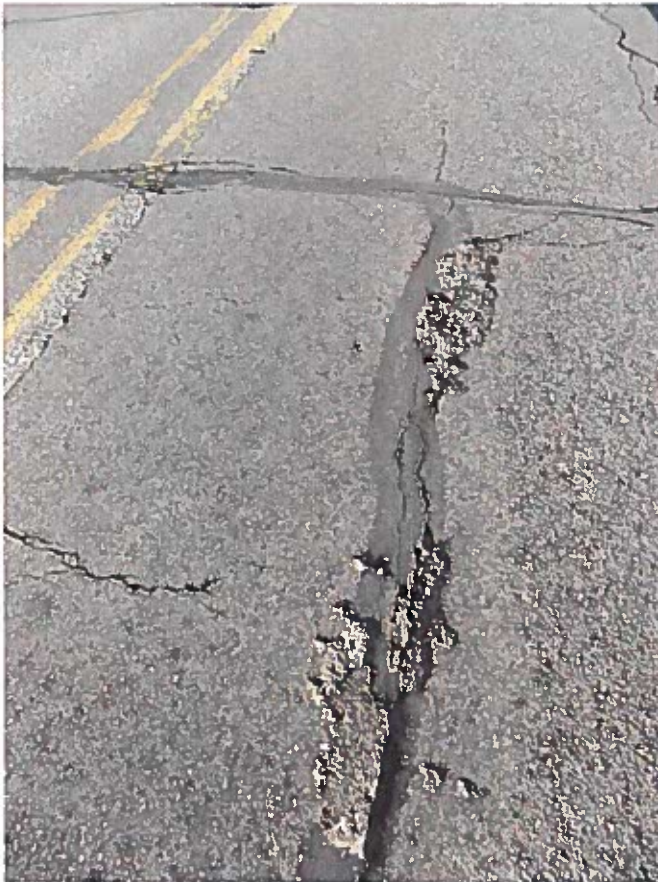
03/14	12/15	11/17	
1. Surface (SIA-58A)	5	5	5	Large block 1/16" to 1/4" cracking entire surface with shallow spalls along centerline. (11/17) Numerous open random 1/16" to 1/4" cracks. (12/15) Numerous open random 1/16" to 1/8" cracks. (03/14)

Document Name: 051.JPG
 Category: Deck
 Span Number:
 Comments: Typical surface cracking & spalling.

Recommendation Type	Priority	Description
Deck Patching	H	Hot patch and crackseal HMA surface on bridge and approaches. Monitor seal at shoulder/bridge rail interface for leakage into fill.

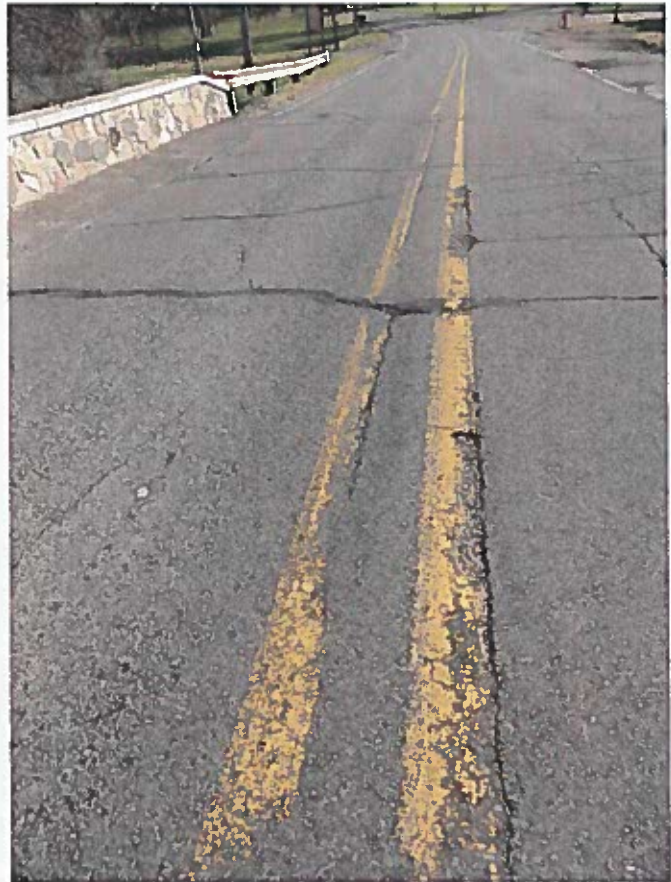
Document Name: 052.JPG
 Category: Deck
 Span Number:
 Comments: Cracking & spalling in bridge surface.

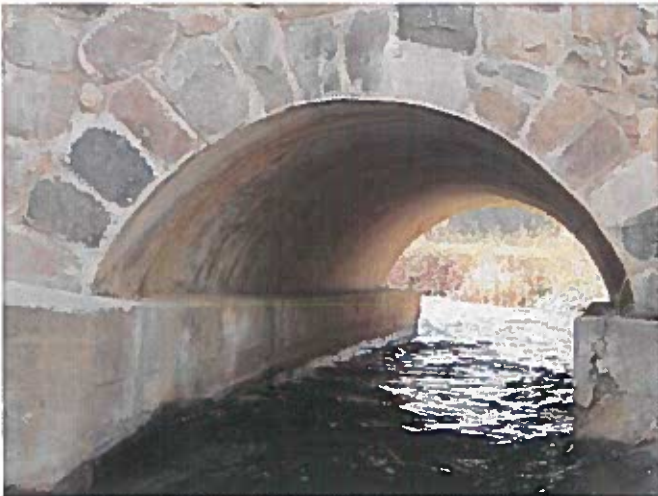
Document Name: 031.JPG
 Category: Other
 Span Number:
 Comments: Typical arch interior.

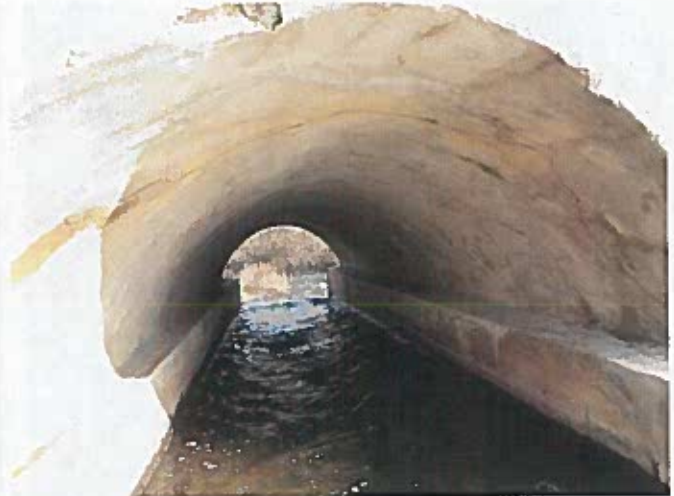
Document Name: 050.JPG
 Category: Other
 Span Number:
 Comments: Typical arch interior.

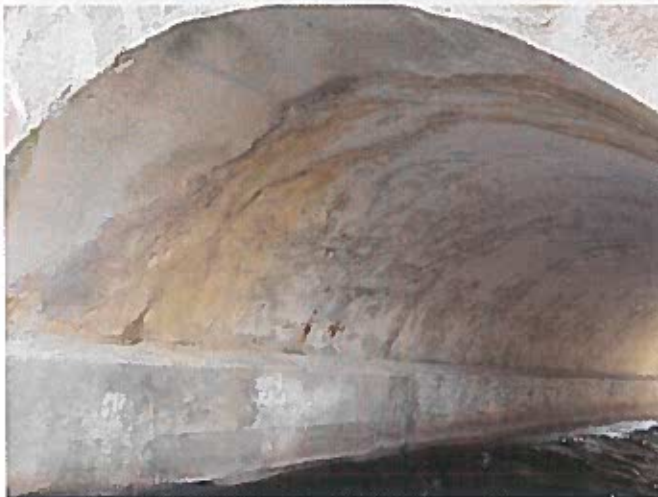
9. Stringer (SIA-59)	6	6	5	Interior arch lining repair areas OK but many hairline to 1/16" cracks with rust staining. Numerous hairline to 1/8" cracks beyond repaired areas. (11/17) Repairs holding up well that were made to interior arches lining at downstream end of arches. Numerous hairline to 1/8" cracks beyond repaired areas. (12/15) Repairs to interior arches lining made at downstream end of arches. Numerous hairline to 1/8" cracks beyond repaired areas. (03/14)
10. Paint (SIA-59A)	N	N	N	(11/17) (12/15) (03/14)
11. Section Loss	N	N	N	(11/17) (12/15) (03/14)
12. Bearings	N	N	N	(11/17) (12/15) (03/14)

Document Name: 053.JPG
 Category: Other
 Span Number:
 Comments: Typical cracking and rust staining at arch repairs.
