STR 4532

BRIDGE SAFETY INSPECTION REPORT

Facility MILL STREET	Latitude / Longitude 42.11 / -84.2457	MDOT Structure ID 384093200038B01	Structure Condition Fair Condition(5)
Feature SO BRANCH RAISIN RIVER	Length / Width / Spans 34.8 / 25.6 / 3	Owner City: BROOKLYN(0932)	
Location 0.10 MI E OF M-50	Built / Recon. / Paint / Ovly. 1925 / 1984 / /	TSC Jackson(15)	Operational Status P Posted for load(17NNNN)
Region / County University(6) / Jackson(38)	Material / Design 8 Masonry / 11 Arch- Deck, Filled Sp	Last NBI Inspection 11/21/2017 / VMC8	Scour Evaluation 5 Stable w/in footing

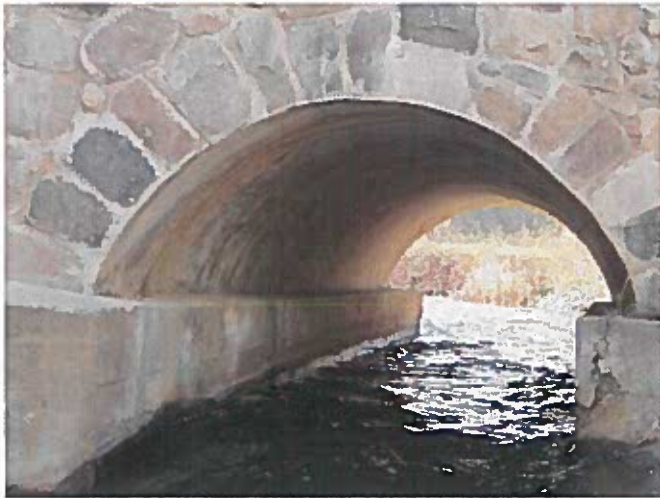
Document Name: 031.JPG
 Category: Other
 Span Number:
 Comments: Typical arch interior.

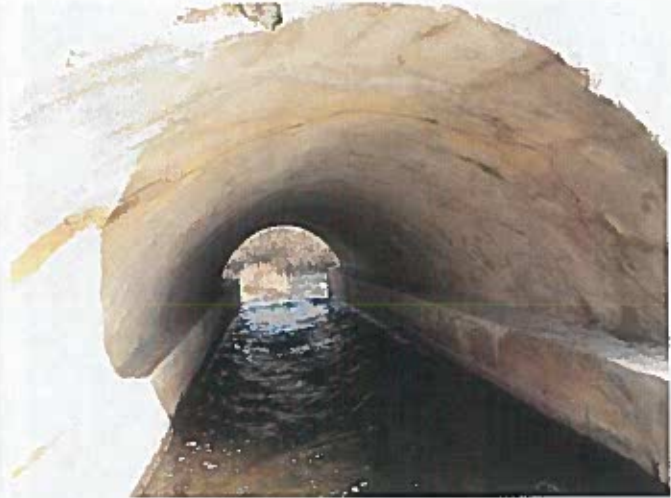
Document Name: 050.JPG
 Category: Other
 Span Number:
 Comments: Typical arch interior.

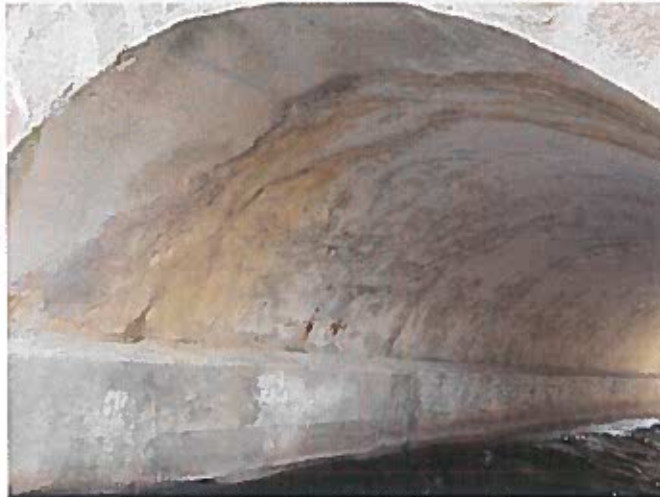
9. Stringer (SIA-59)	6	6	5	Interior arch lining repair areas OK but many hairline to 1/16" cracks with rust staining. Numerous hairline to 1/8" cracks beyond repaired areas. (11/17) Repairs holding up well that were made to interior arches lining at downstream end of arches. Numerous hairline to 1/8" cracks beyond repaired areas. (12/15) Repairs to interior arches lining made at downstream end of arches. Numerous hairline to 1/8" cracks beyond repaired areas. (03/14)
10. Paint (SIA-59A)	N	N	N	(11/17) (12/15) (03/14)
11. Section Loss	N	N	N	(11/17) (12/15) (03/14)
12. Bearings	N	N	N	(11/17) (12/15) (03/14)

Document Name: 053.JPG
 Category: Other
 Span Number:
 Comments: Typical cracking and rust staining at arch repairs.
